Jerry Holcomb
Consulting Arborist

March 20, 2014

Re: Evaluation of Live Oak Trees at 2285 US Highway 17

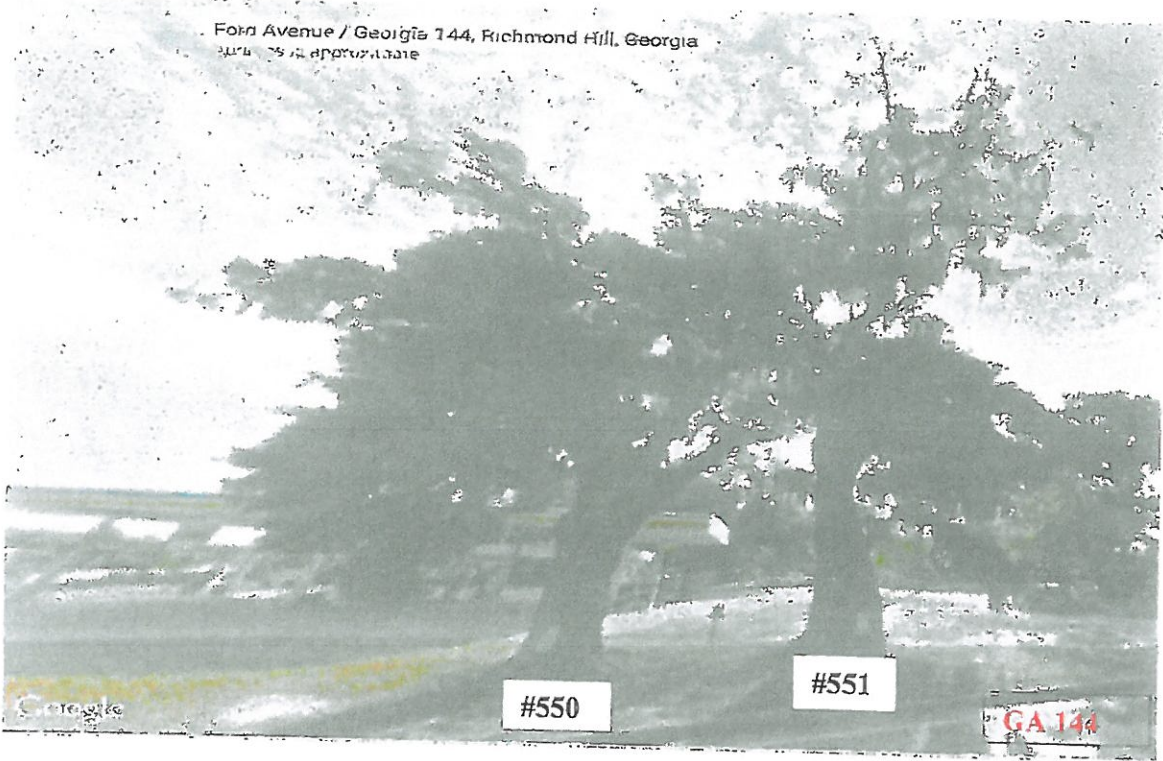
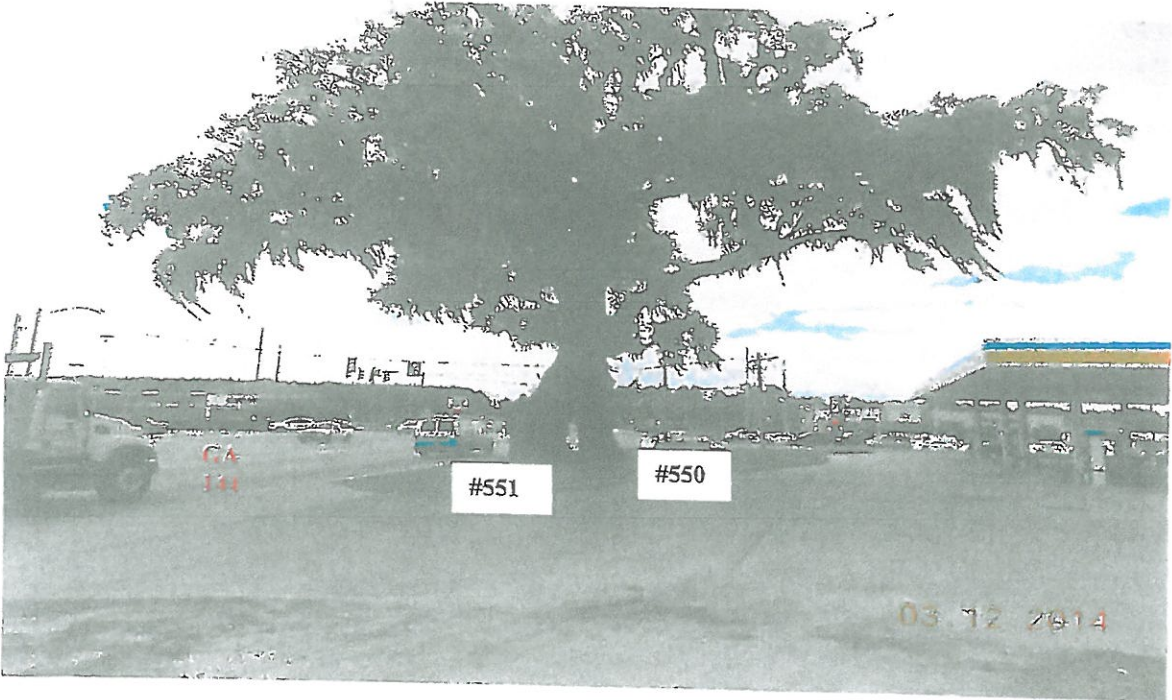
Exhibit 1

Location at intersection of US 17 and GA 144

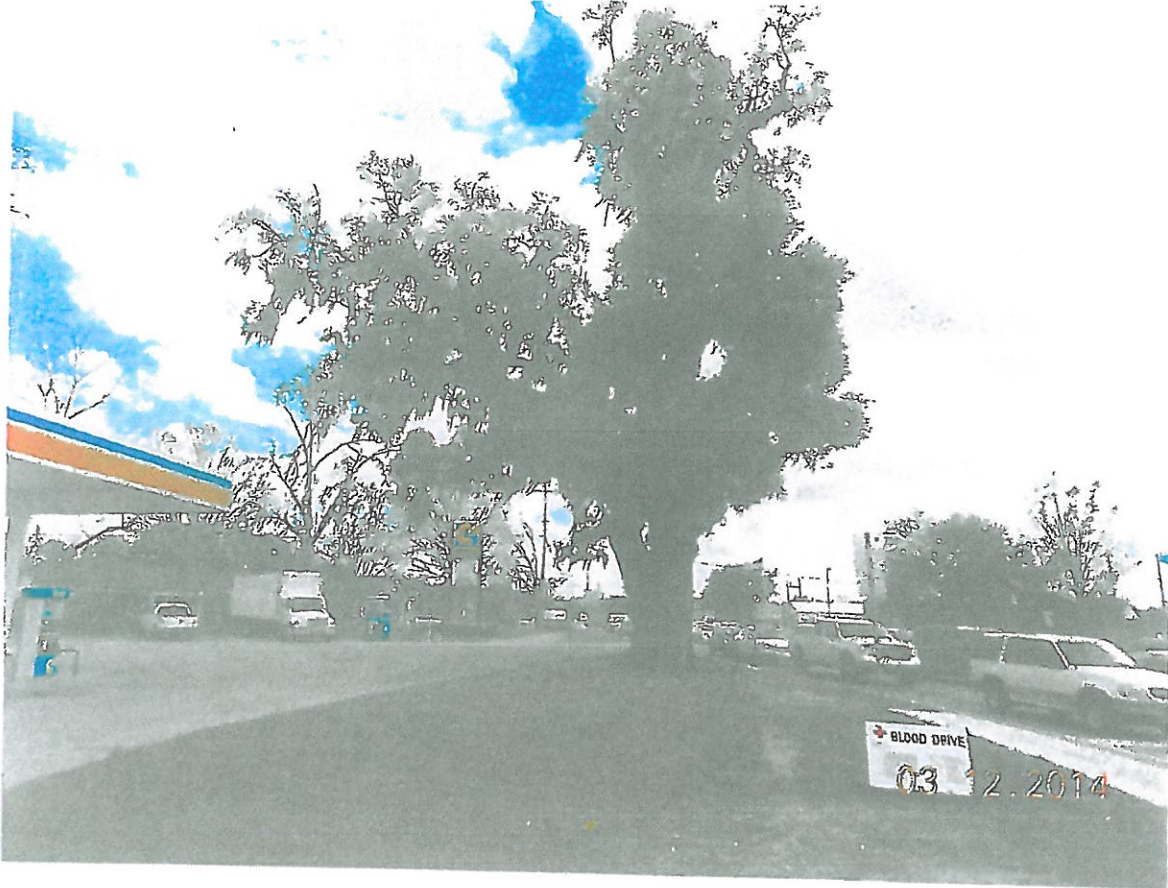
Exhibit 2

1. City of Richmond Hill is concerned about potential tree failure.
2. Both trees are aging mature Live Oaks in a declining situation.
3. Trees are growing in an island on GADOT right-of-way at intersection of GA 144 and US 17 on the eastside of intersection Exhibit 2.

Trees growing in an island area

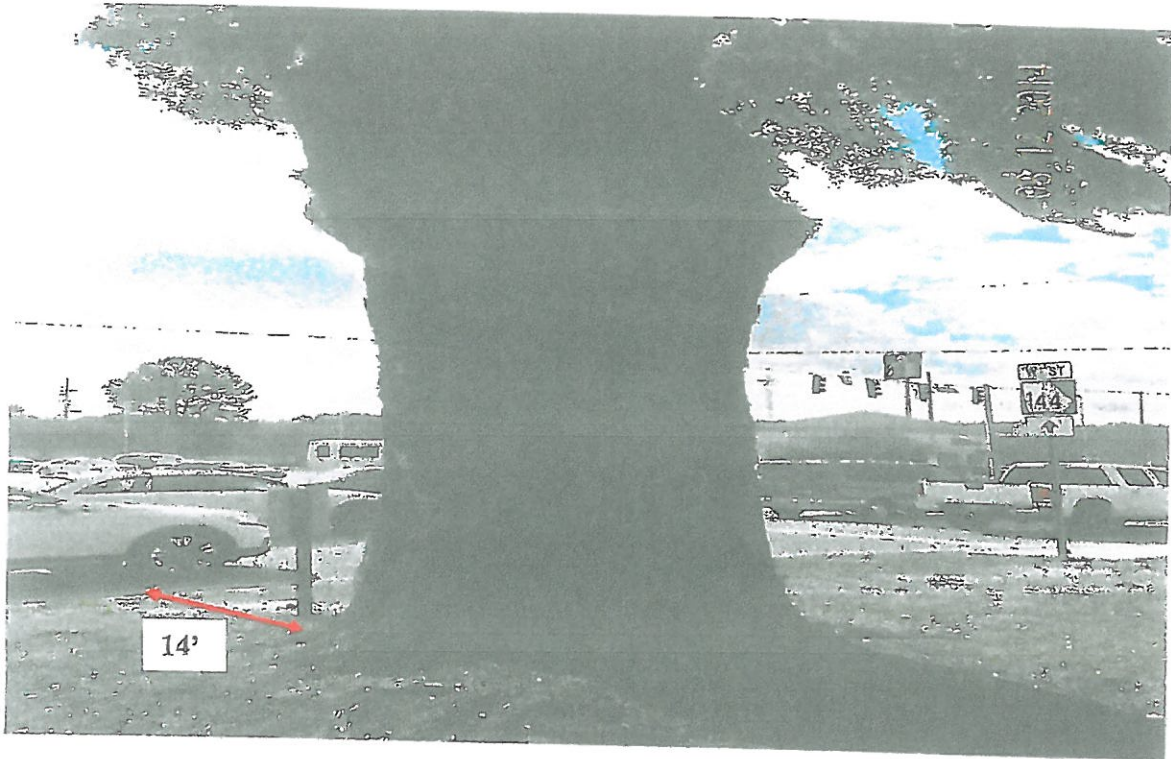
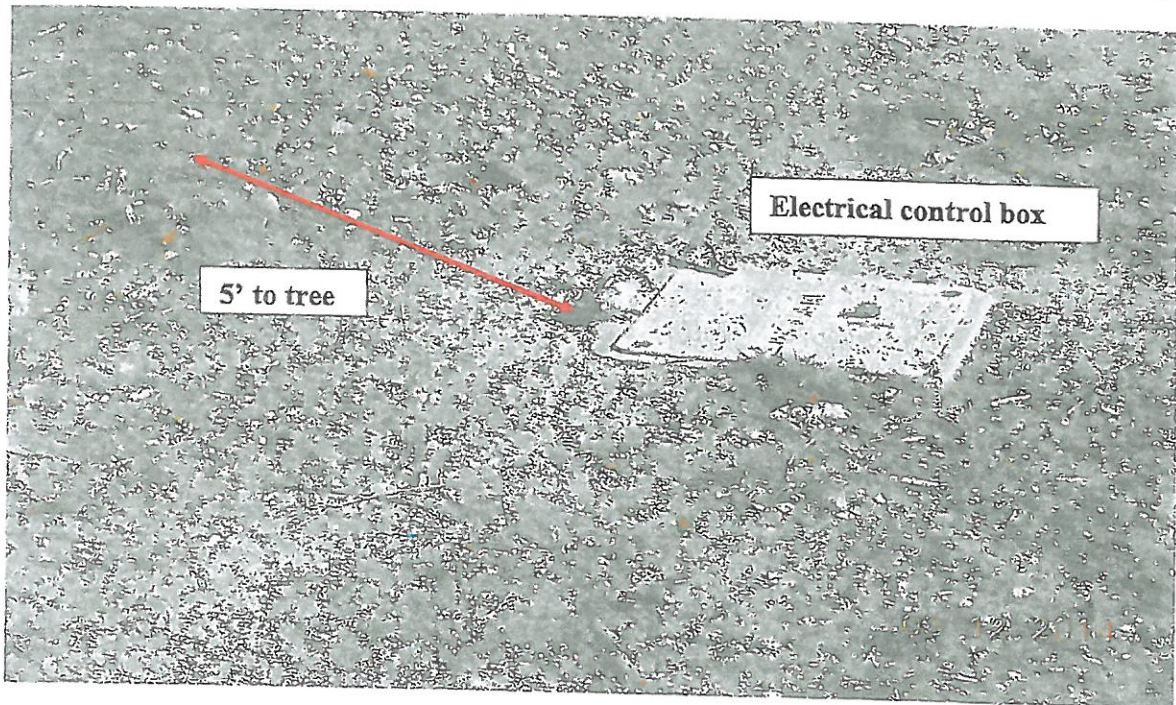
Exhibit 3

4. Recent widening of road way and construction in August 2013 has encroached within the critical root zone of the tree's roots causing damage to the tree's roots, by cutting roots to install curbing and installation of electrical boxes for signal control's.

Overall health of the tree is in a declining situation due to several factors; 1) widening of the street has cut roots to a certain degree to within 14' of the trunk of the tree; 2) installation of an electrical control box in the ground within 5' of the trunk of the tree has severed roots for lines to be connected to control panel Exhibit 3; 3) the removal of a large scaffold branch over 26" in diameter has left a wound area which has developed into a sizeable cavity that runs from the major scaffold branch area down to the ground Exhibit 4; 4) the live crown ratio is less 50% with new growth being sparse with evidence of deadwood in crown area; and 5) remaining soil area within the critical root zone area is compacted.

Curb cut to within 14' of trunk of tree and installation of electrical control box cut roots

It is the professional opinion and recommendation of this arborist that abatement options cannot reduce the hazard situations presented, therefore these trees should be removed. However, this decision is left up to the owner or managers of the trees and how much risk they are willing to assume.

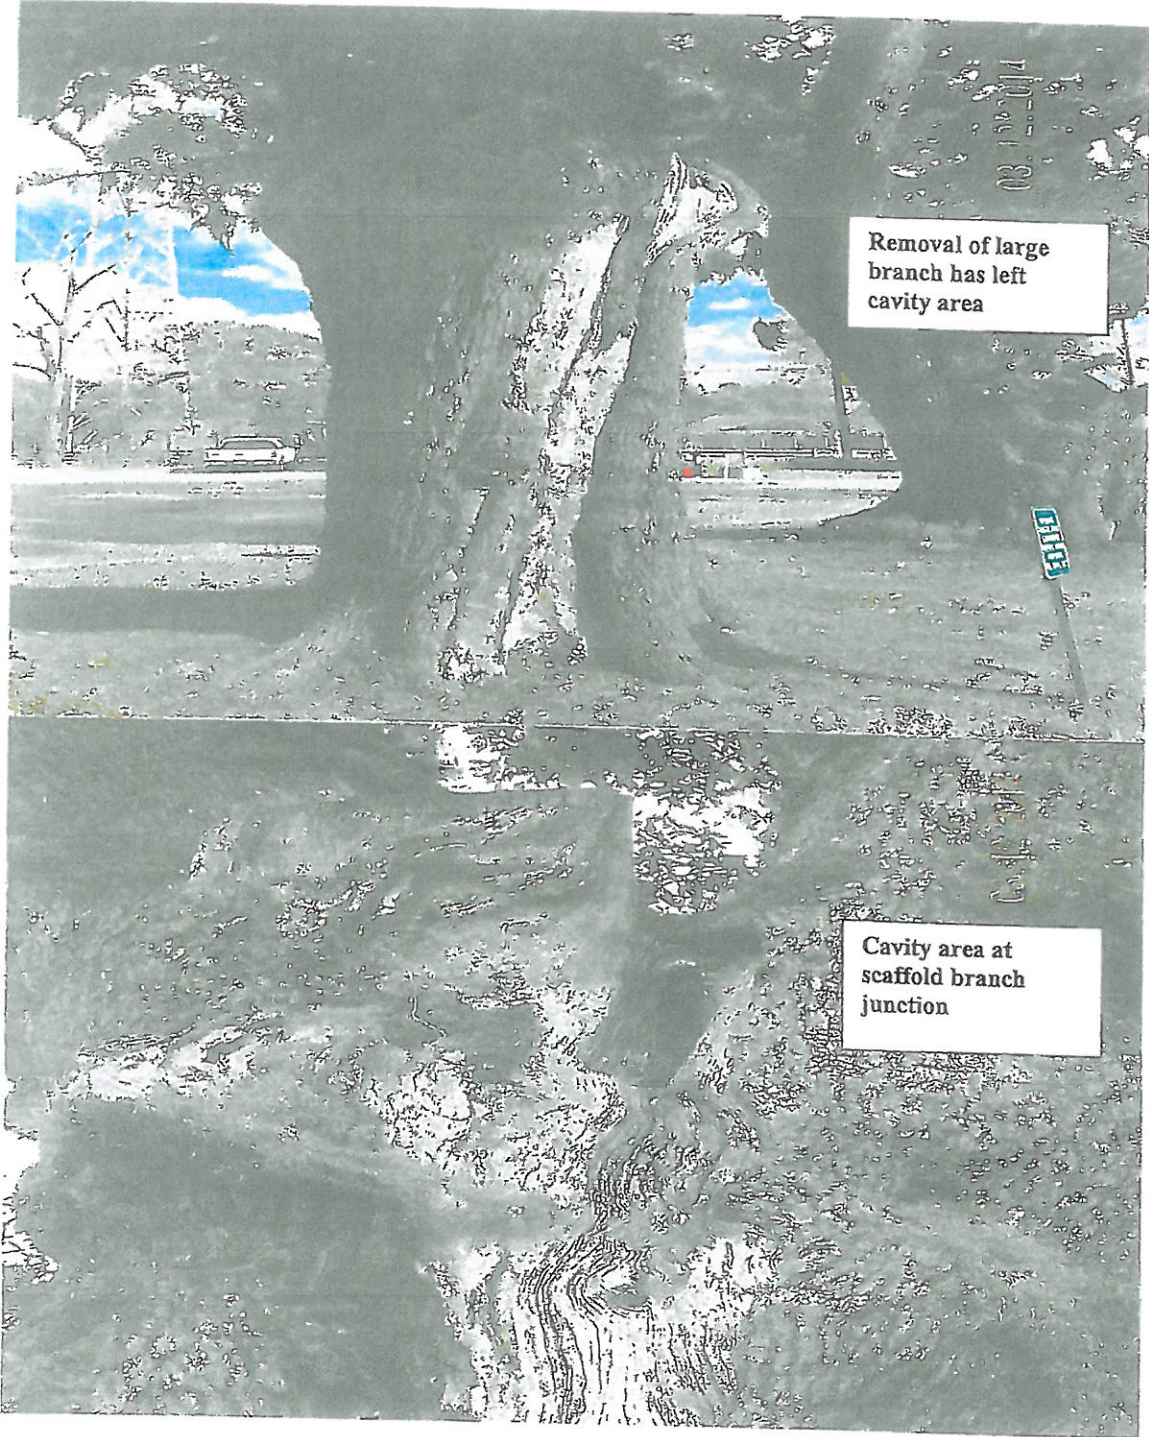
Exhibit 4

This is a 53.5" diameter native Live Oak single trunk, decurrent growth habit tree with major scaffolding branches. The tree is growing in an island between the street and a commercial business establishment. The live crown ratio is less than 50%, and the tree is in the over-mature age category. The tree has had multiple pruning events in its history with one large scaffold branch about 26" in diameter being removed. Critical root zone of the tree has been compromised with widening of GA 144. The tree due to its age category is classified as a heritage street tree.

Failure potential:	3
Size of defective part:	3
Target rating:	4
<hr/>	
Hazard Rating:	10

Removal of a large scaffold branch over 26" in diameter has left a wound area which has developed into a large cavity that runs from the major scaffold branch area down to the ground.

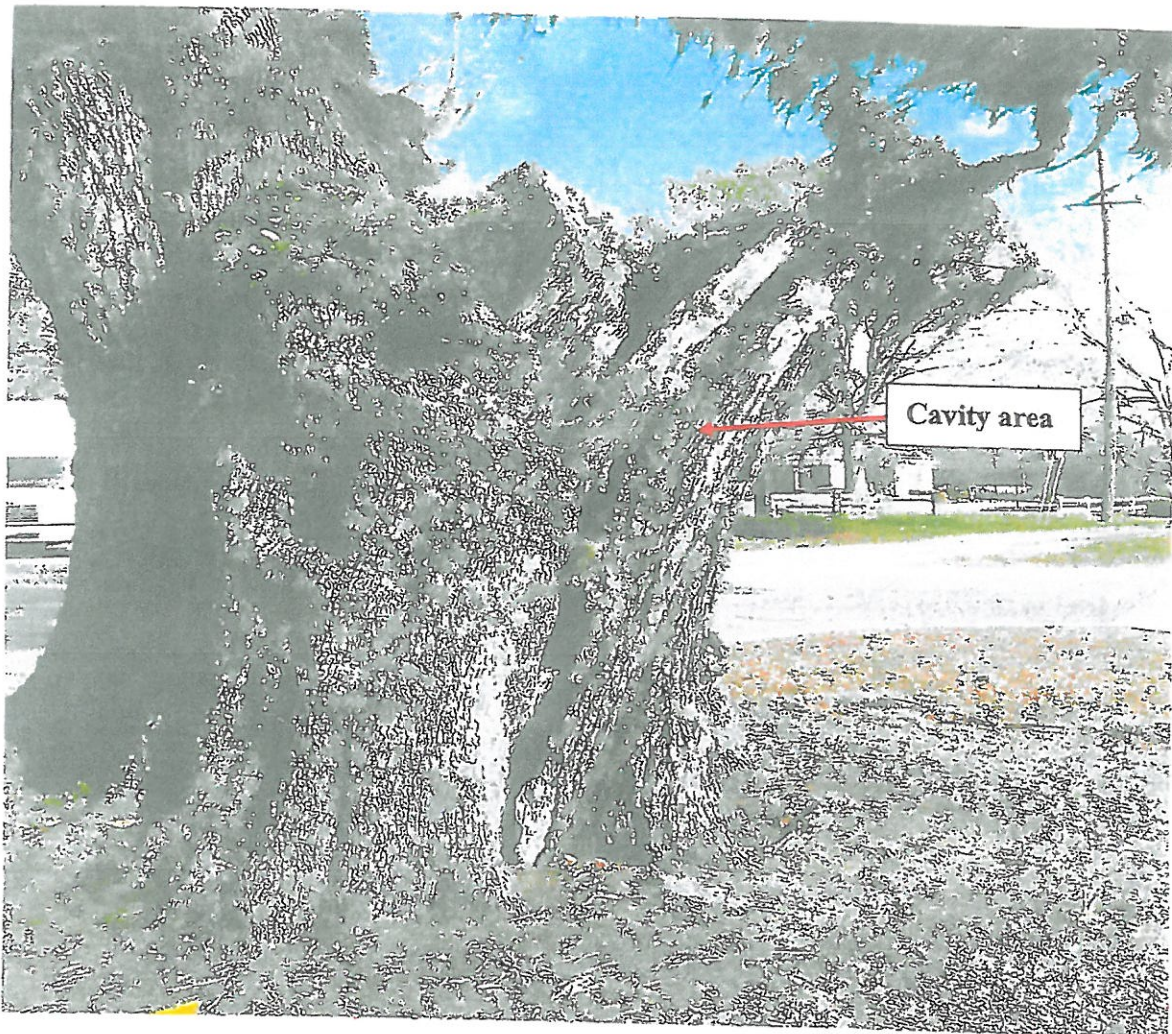
Exhibit 5

Overall health of the tree is in a declining situation due to several factors; 1) widening of the street has cut roots to within 9' of the trunk of the tree; 2) the removal of one of the co-dominant boles has left an area that has developed a large cavity in the trunk area of the tree Exhibit 5; 3) the live crown ratio is less 50% with evidence of deadwood in crown area and die-back of branches; and 4) the remaining root zone area of the tree has been cut 75% and remaining soil area within the critical root zone area is compacted.

Failure potential:	3
Size of defective part:	3
Target rating:	4
<hr/>	
Hazard Rating:	10

Removal of one of the co-dominant boles has left an area that has developed a large cavity in the trunk area.
